**VANANDA GOLD LTD.**

**TEXADA ISLAND PROPERTY**  
NANAIMO, B.C.

## **PROPERTY GEOLOGY**

MINEQUEST EXPLORATION ASSOCIATES LTD.

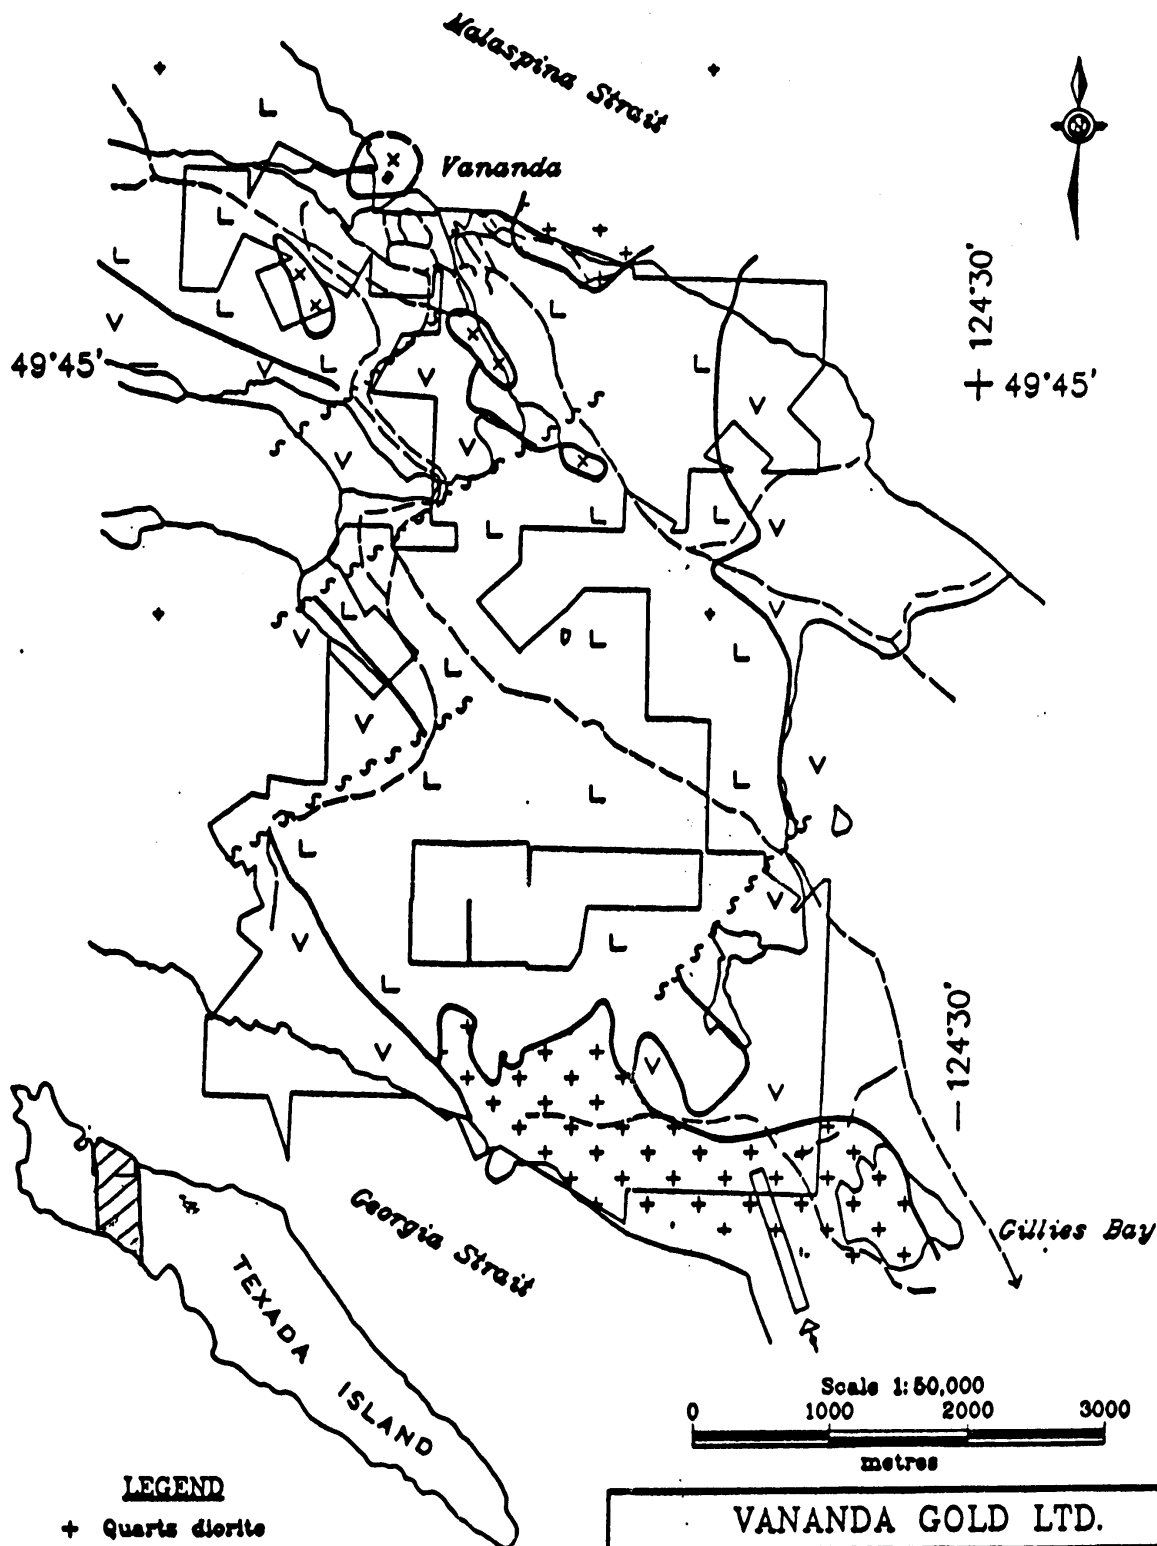
DATE: NOV. '85 | N.T.S.: 927/102 162 | FIGURE: 3

- + Quartz diorite
- x Diorite, gabbro
- L Quaternary limestone
- V Kermiteen volcanics
- Fault

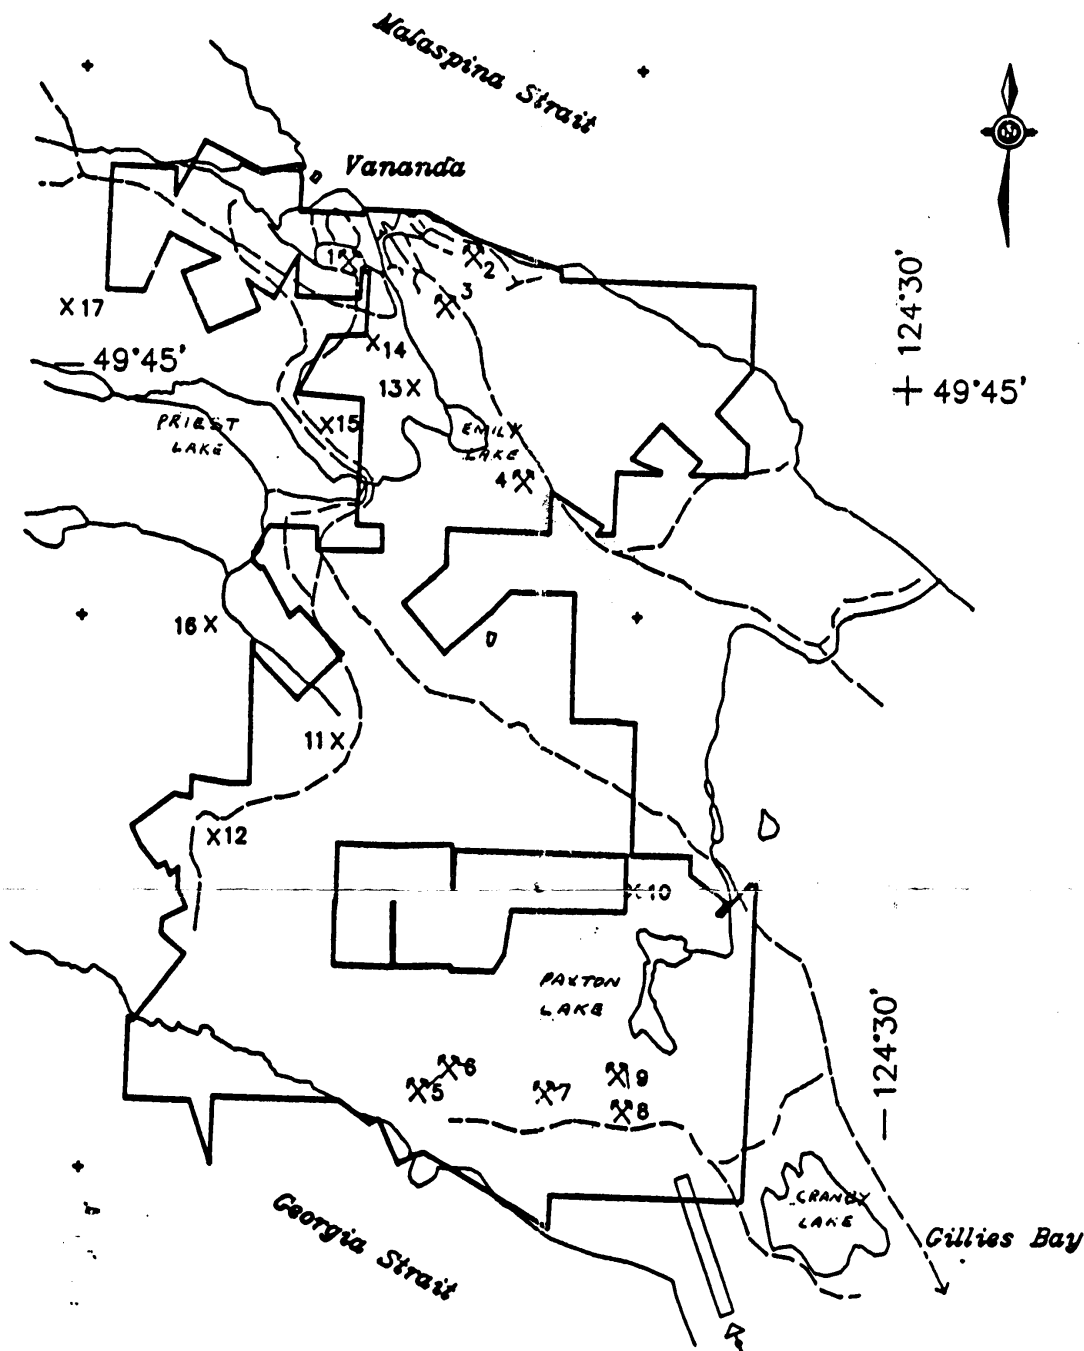
DATE: NOV. '86 N.T.S.: 927/10E, 15E FIGURE: 4

- 1 Marble Bay Au,Cu,Ag
- 2 Little Belle Au,Cu,Ag
- 3 Copper Queen Au,Cu,Ag
- 4 Cornell Au,Cu,Ag
- 5 Prescott Fe,Cu,Au,Ag
- 6 Yellow Kid Fe,Cu,Au,Ag
- 7 Paxton Fe,Cu,Au,Ag
- 8 Lake Fe,Cu,Au,Ag
- 9 Lake Cu,Au,Ag

- 10 Sentinel Pb,Zn,Ag,Au
- 11 Commodore Cu,Pb,Ag,Au
- 12 Ideal Pit Zn,Au,Ag
- 13 Florence Fe,Cu,Au
- 14 Security Fe,Cu,Au
- 15 Priest Lake Au,pyr.
- 16 Holly Au
- 17 Marjorie Au

LOCATION OF MINES AND  
MINERAL OCCURRENCES

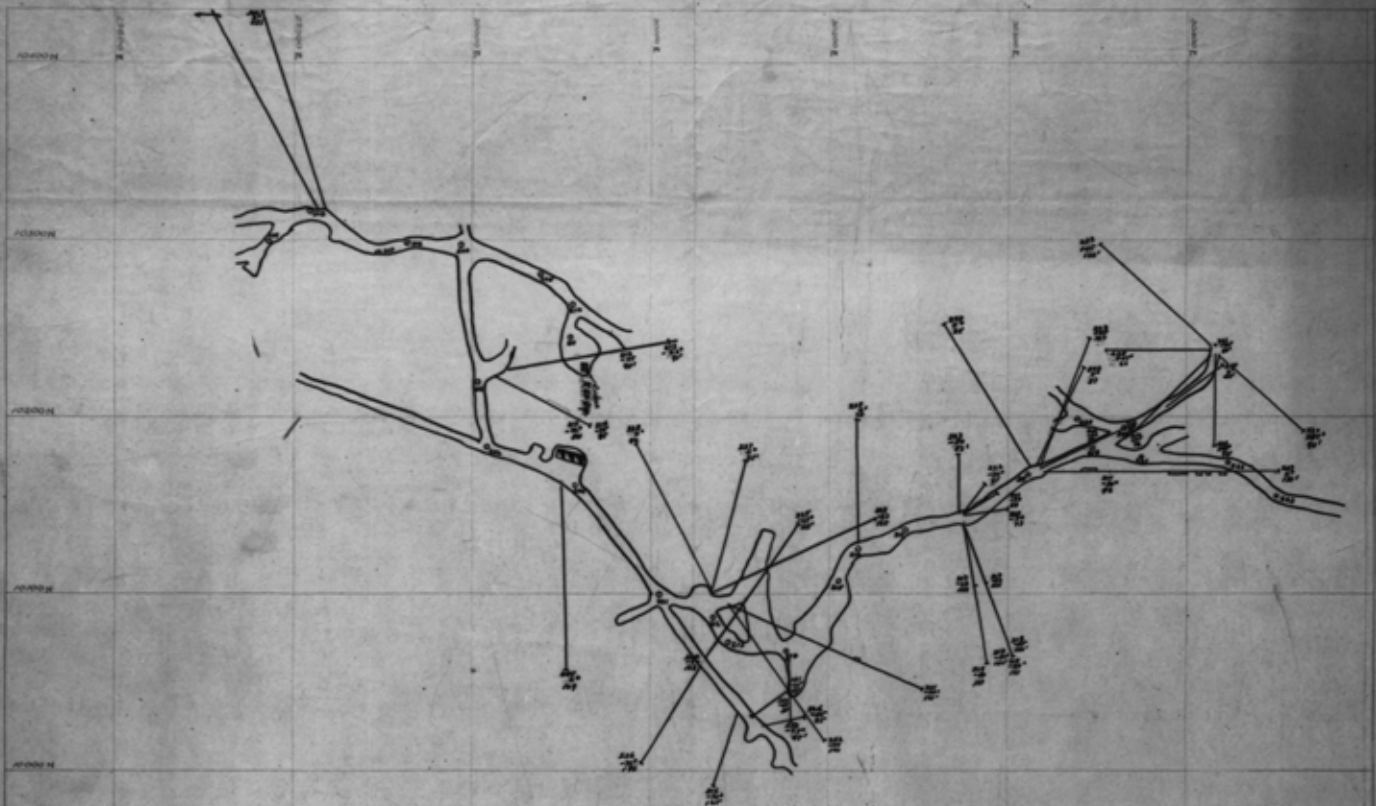
VANANDA MINES (1948) LTD.  
No. 3 LEVEL (100 LEVEL)  
SCALE 1" = 50' MARCH 1949
